**TO BALANCE THE BUFFER TO PREVENT IT  
FROM PULLING TO THE SIDE OR PUSHING  
BACKWARDS FOLLOW THESE STEPS:**

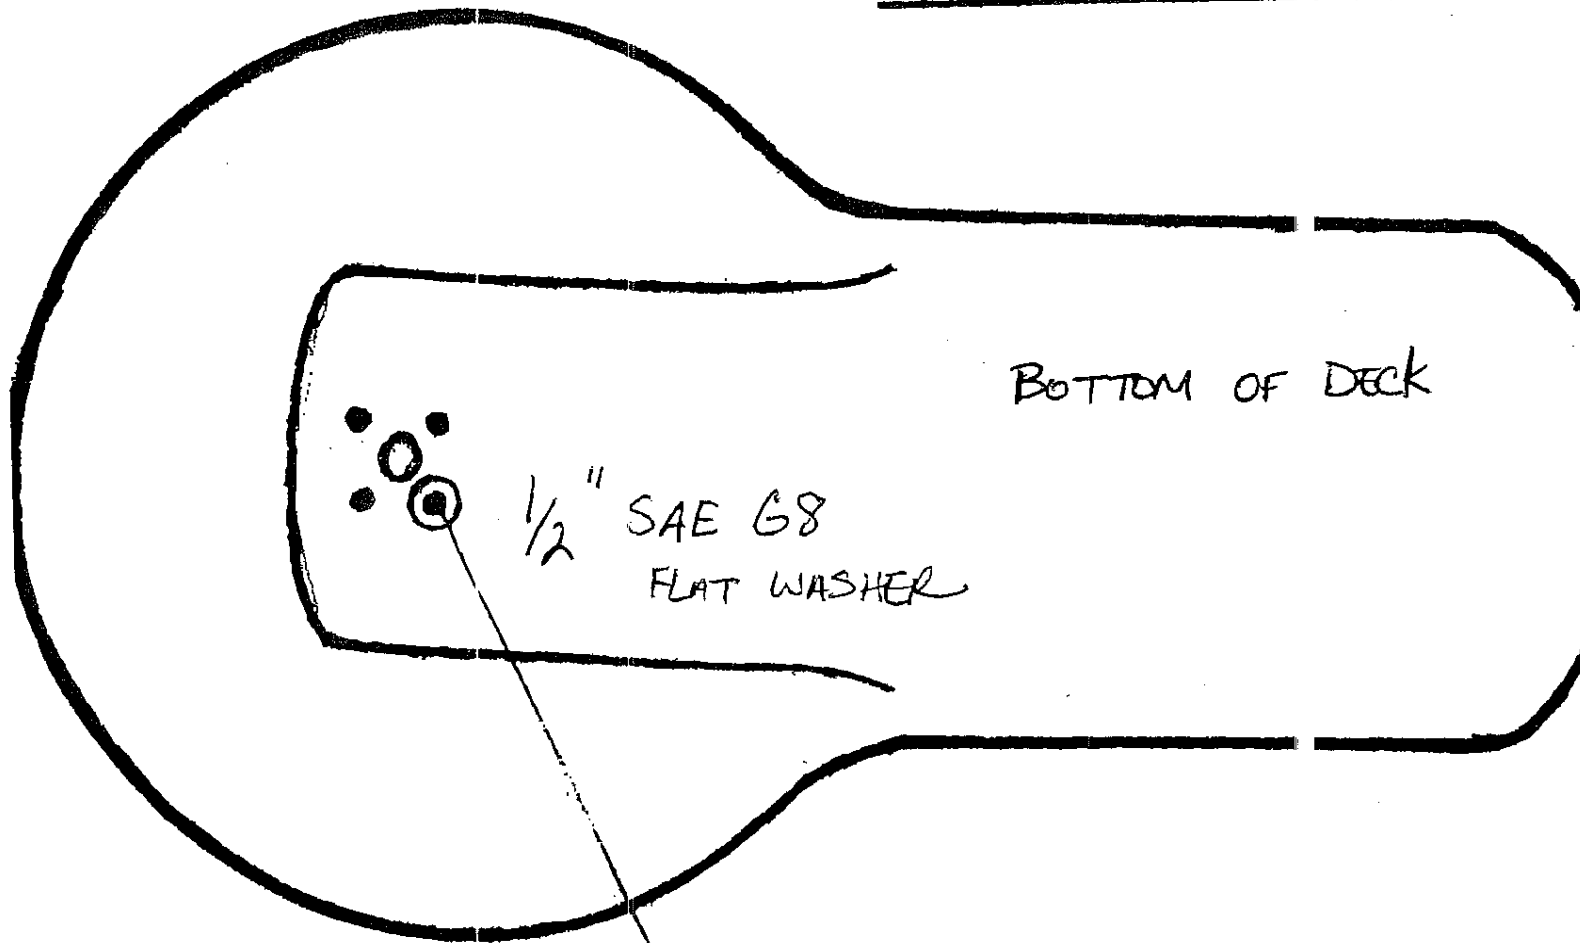
SPACER/WASHER  
MOUNT BETWEEN DECK  
+  
FRONT END ASSEMBLY

The following pages show both how we correct the problem of torque during production and an in use solution. During production we place one 1/2" washer between the front bearing assembly and the main deck/frame (24" & 28" only). This tilts the bearing assembly slightly to the right which also tilts the pad driver to the right. This puts more pressure on the pad driver on the right side which because of the direction of rotation causes the buffer to pull slightly forward. If any service work has been done on these buffers and that washer was left out it will cause the buffer to pull hard to the left or push backwards. The second sheet shows how to place washers over the front bearing assembly shaft which raises the front of the buffer ever so slightly providing the same desired effect. Please note that you may have to experiment with one or more washers to get the desired results. Also there are a few other factors to examine: Aggressiveness of the pads / Wheel Position - further forward means less head pressure and further back provides more head pressure / Condition of the Wheels - if the wheels are very worn it can affect the balance of the buffer / Condition of the Floor - because these buffers are operating at @ 2000rpm's any high spots or imperfections in the floor can cause the pad driver to grab and the machine to pull in different directions. I hope this information will help solve the problems you are having, but please feel free to contact us if you need additional help or information.
