PRODUCT CHANGE UPDATE

Subject: The MM14QP (EZ Mop 360) has 14 new improvements.

All MM14QP EZ Mops, starting with serial number D40ML7605 and following.
New versions started shipping on 02/27/2020 and thereafter.

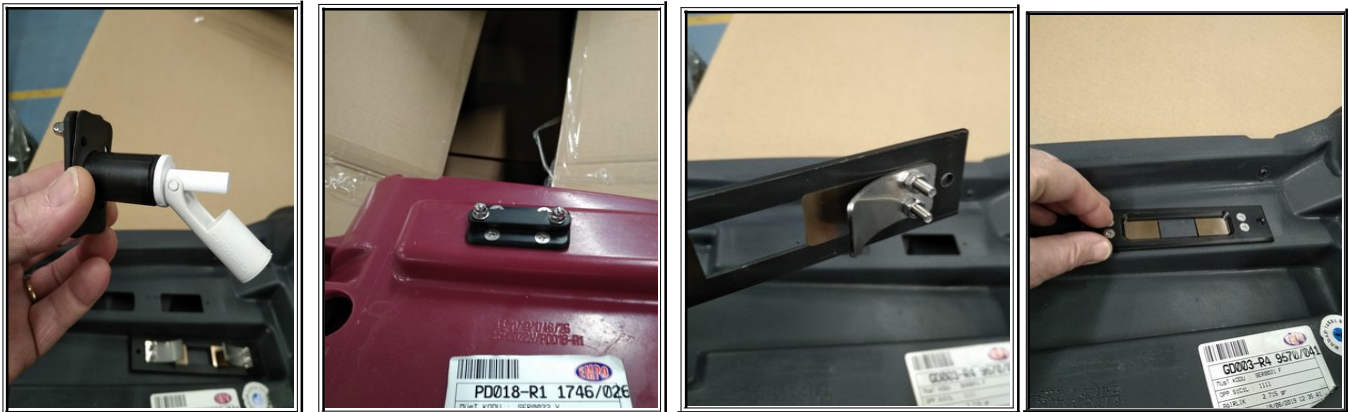
Improvement 1. New float system will be included in the recovery tank in order to turn off vacuum motor, when the tank is full. (Below)

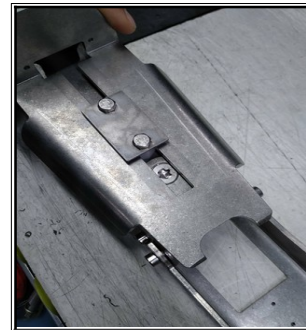
Improvement 3. The metal handle support has been strengthened by increasing the thickness from 4mm to 6mm. In addition, there is a new reinforced screw in order to prevent the support from bending or breaking. (Below)

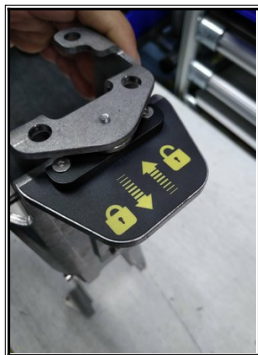
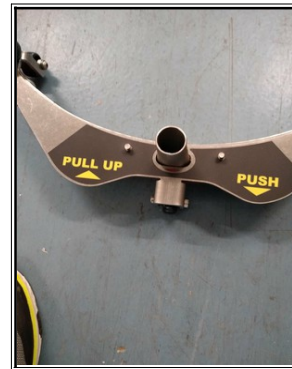
Improvement 4. New instruction decals have been added to the squeegee lifting and locking system. (Below)

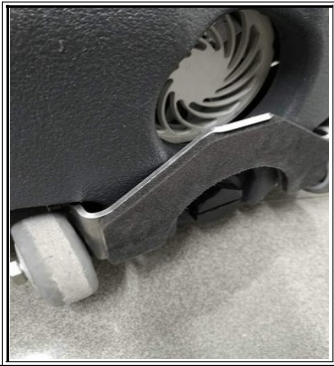
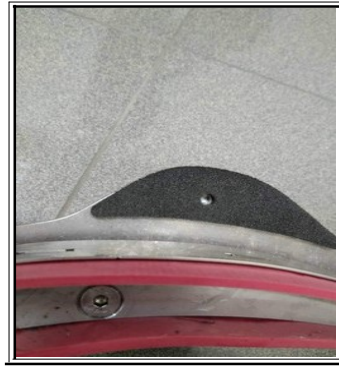
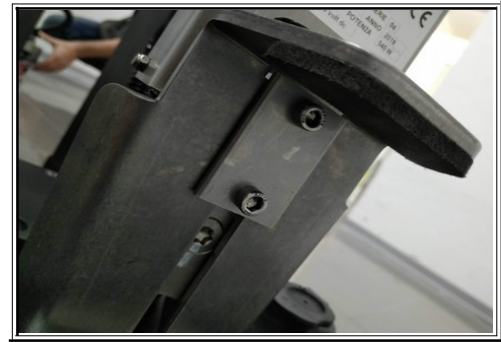
Improvement 6. New rubber gasket has been added under the squeegee and locking lever to prevent damage to the operator's shoes. (Below)

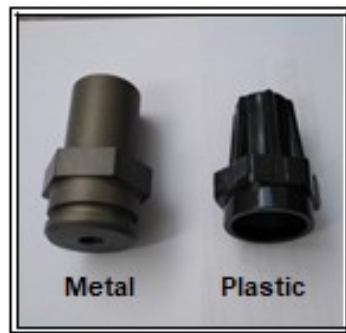
Improvement 7.

The brush couplings have changed from plastic to aluminum for added strength. (Picture on right)

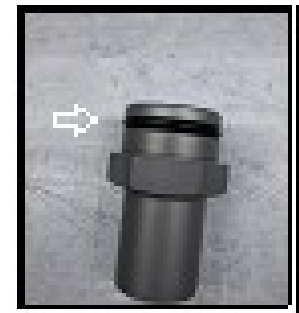
Improvement 8.

New improved O-rings on the brush couplings. The O-rings will be black in color for easy identification. The older ones were red. (Picture on right)

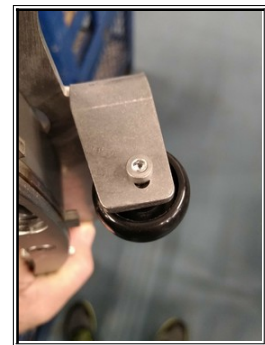
Improvement 10.

The squeegee will have an adjustable back wheel. (Picture on right)

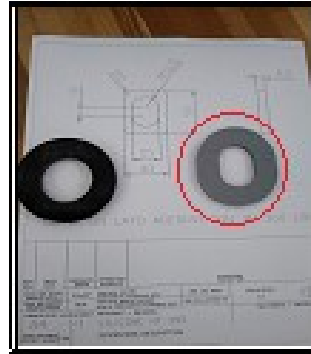
Improvement 11. The new silicon gasket for recovery tank (part number 830262) is more resistant and it will prevent the water from leaking. Circled in red. (Picture on right)

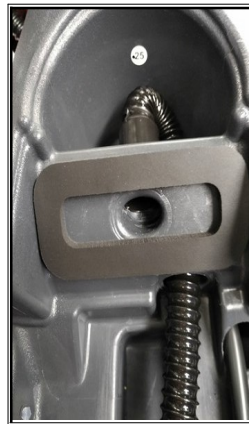
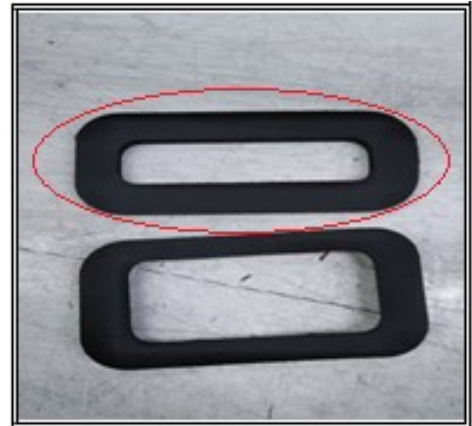
Improvement 12. The new gasket will make a better seal to the recovery tank. Gasket with the red circle is the new gasket. (Both pictures on the right)

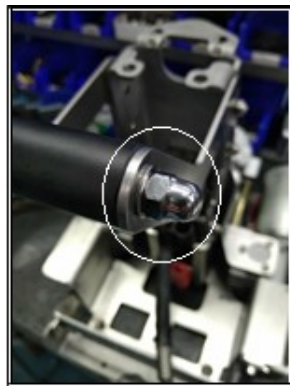
Improvement 13. The end of the main handle has a new closed nut, instead of the plastic nut cap. (Picture on right)

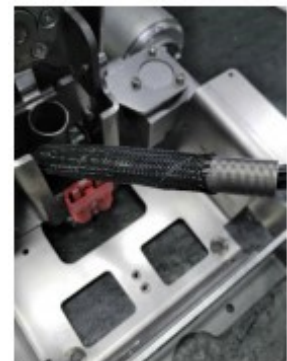
Improvement 14. The new stainless steel spring and a PVC net on the motor wiring harness prevents the wires from being cut. (Picture on right)
