Scrubmaster B400R / RM / RH

Checking washers on drive controller

Page 3 NEWS KUD 2024-08 from 28.03.2024

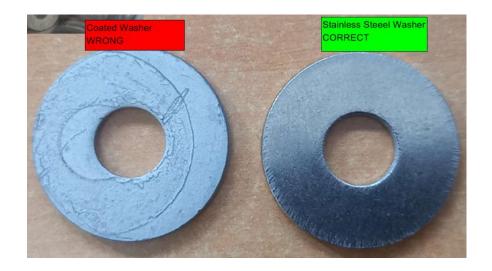
Please travel immediately to the machines on the list and check whether the correct washers have been installed on the drive control fuse. Incorrect washers can cause short-term damage to the drive controller.

Drive controller front

Drive controller rear

<u>Up to</u> **8pcs** washers ISO 7093-8-200HV-A4-70 with the **spare part number 00902280** must be replaced. The screws must be tightened with **9.5 Nm**.
