## **Installation Instructions**

Wire Assy, Horn Fix Part #260685

Replacing Faulty Horn
Circuit Diode, Capacitor On
X3 Harness

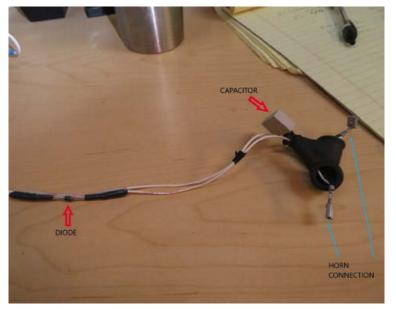
Cut X3 harness wires XS34 and XS35 right behind the diode assembly. Remove and discard Diode/Capacitor portion of harness.

CUT HERE

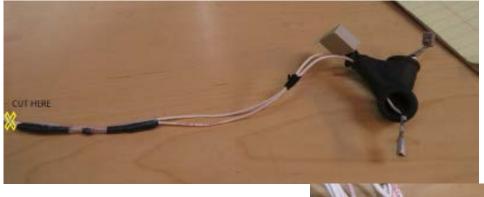
Install female connector (supplied) to X3 harness wire labeled XS34.

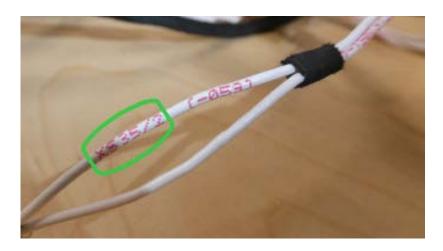
Install male connector (supplied) to X3 harness wire labeled XS35.

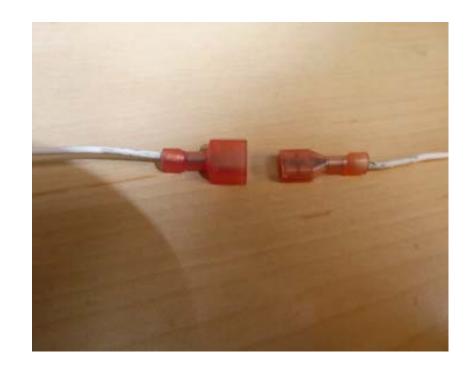
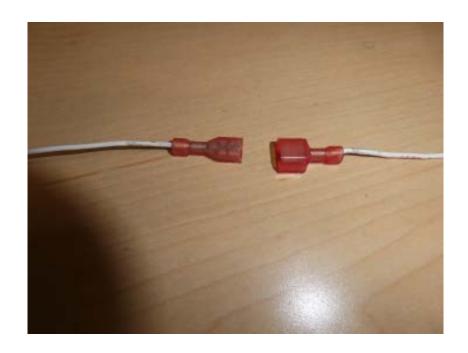
## **Connect wires and reinstall into machine.**
