## TECHNICAL SERVICE BULLETIN

Subject: Repair/Replacement of Diode or Capacitor Horn circuit on X3 Harness for ALL Scrubmaster B175R and B260R series scrubbers.

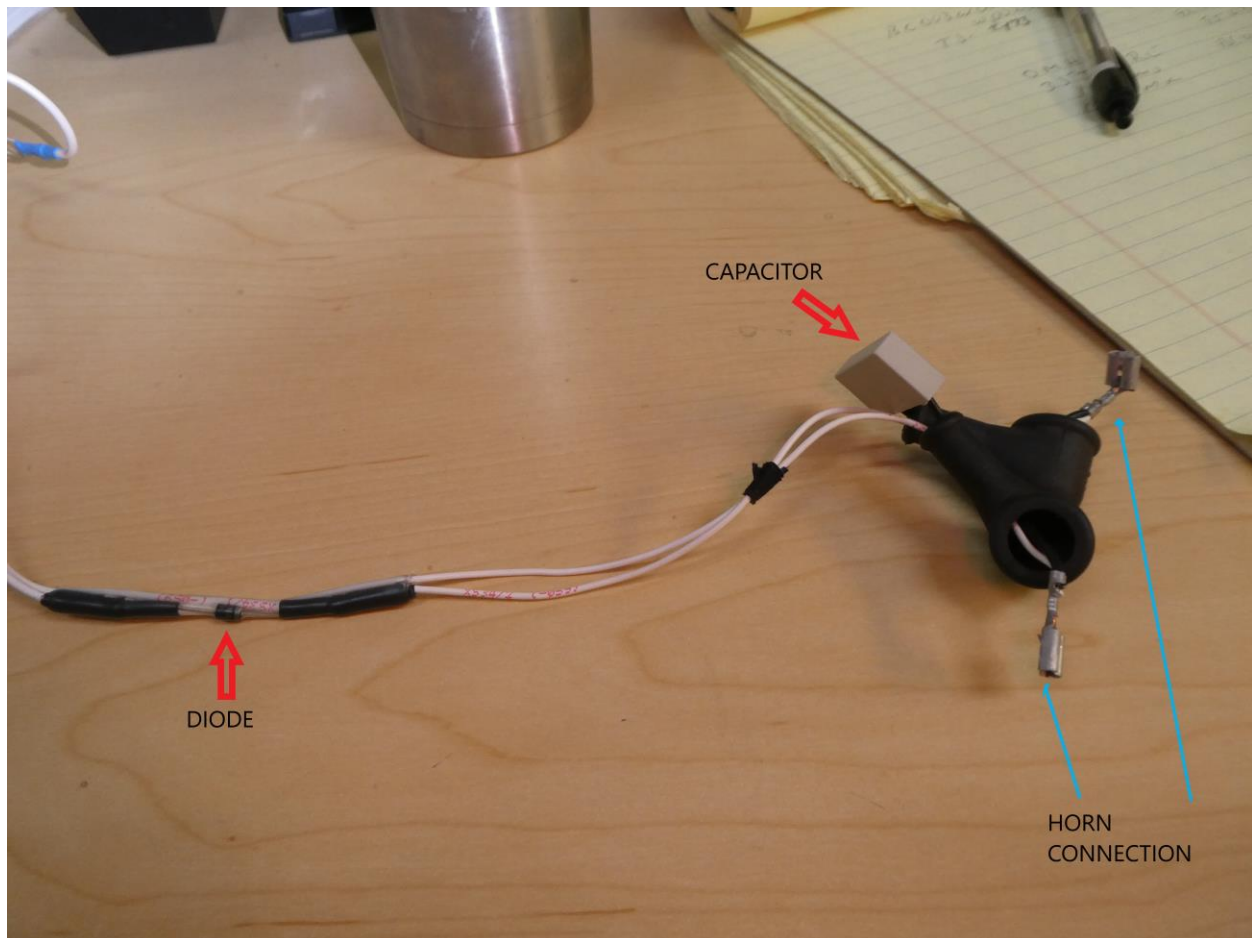
When horn or horn circuit is shorted out, diode or capacitor will short out requiring complete X3 Main Machine Harness replacement. In lieu of replacing complete harness, Kit #K-260685 allows in the field easy repair of this circuit.

Kit #K-260685 allows a horn circuit repair kit to be easily installed in the X3 Main Machine Harness.
