Modem Troubleshooting Guide for BrainOS

Brain Corporation

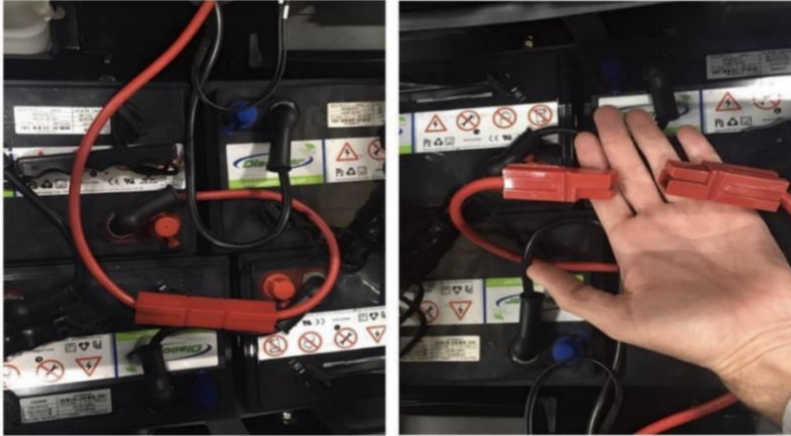
- 1) Manually drive the machine near an outdoor area (such as store entrance or a covered area like a garden center, as applicable to the store). This is for cell reception purposes to avoid obstacles like concrete, EMF from other devices, etc. from interfering with the reception to the modem.
- 2) Turn off the machine.
- 3) Lift the seat and locate the red Anderson connector. Decouple the cables for 3 minutes (timed) then reattach the two ends.

Figure 1: Anderson Connector

- 1) Turn off the machine.
- 2) Raise the seat and decouple the red Anderson connector ([see Figure 1](#)).
- 3) Use a 2.5 mm hex driver to remove the control panel screws.

- 1) Return to the seat area.
- 2) Recouple the Anderson connector ([see Figure 1](#)).
- 3) Turn on the machine.
- 4) After the machine starts up and displays the PIN Code, wait about 3 minutes.
- 5) Verify if the connectivity issue is persisting (checking the ROC icon on the display). If connectivity is established, the ROC icon should be white. If there is still no connectivity, the icons will still be greyed out.

- 1) Turn off the machine, lift the seat and decouple the Anderson connector (see [Figure 1](#)).
- 2) Using a 5 mm hex driver, remove the front plastic shield.

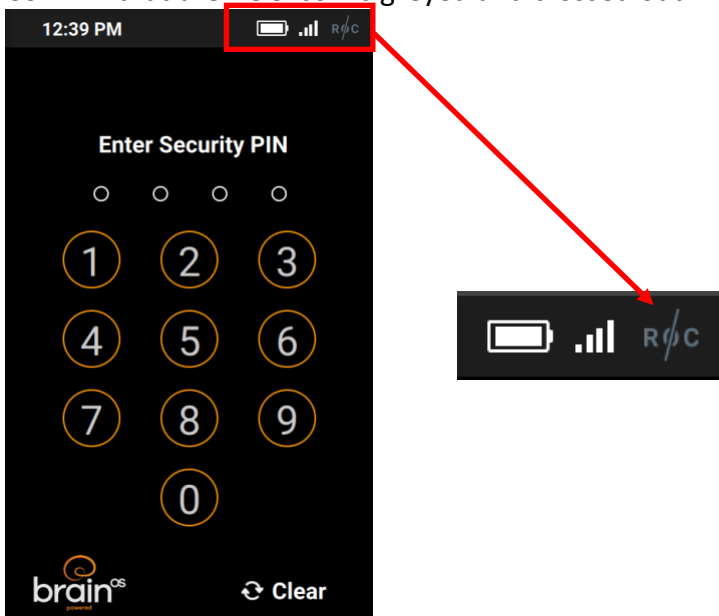
- 4) Restart the machine and wait 2-3 minutes after the machine has fully booted up to the Security PIN screen and for the ROC and other icons to update to the correct status.
- 5) Confirm that the ROC icon is greyed and crossed out.

Figure 2: Security PIN screen and ROC Connection Status

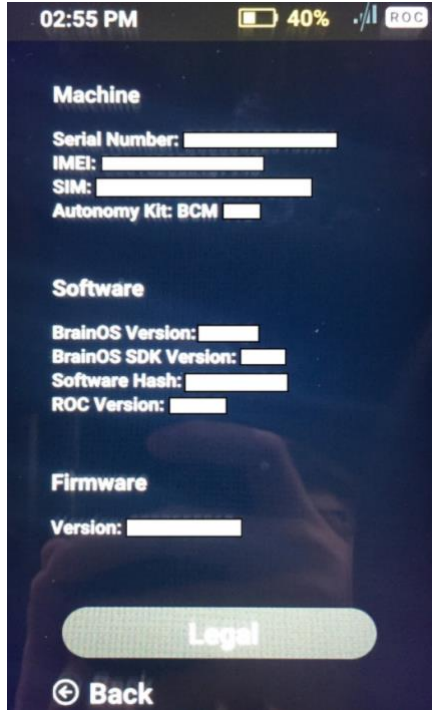
- 6) Once ROC status is confirmed as disconnected, type in the security PIN for the machine.
- 7) Go to Settings -> About to display the machine information.

Figure 3: About screen

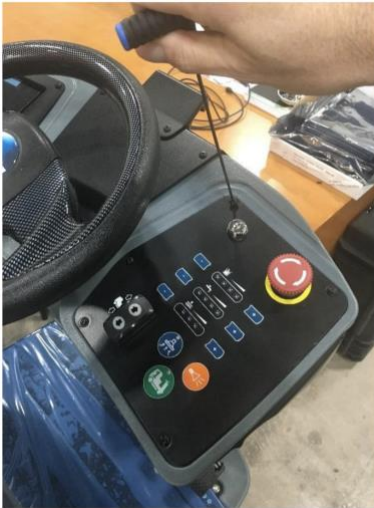
Figure 4: Control Panel

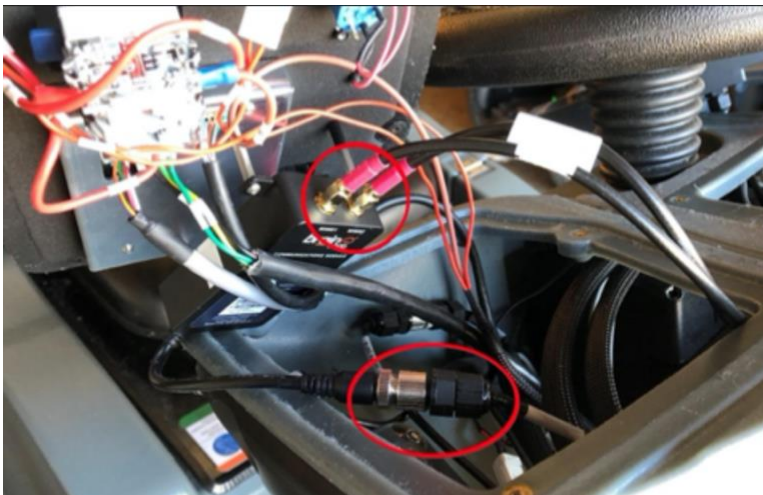
- 4) Lift up the control panel to expose the modem mounted on the underside of the panel.

Figure 5: Modem Mounted underneath Control Panel

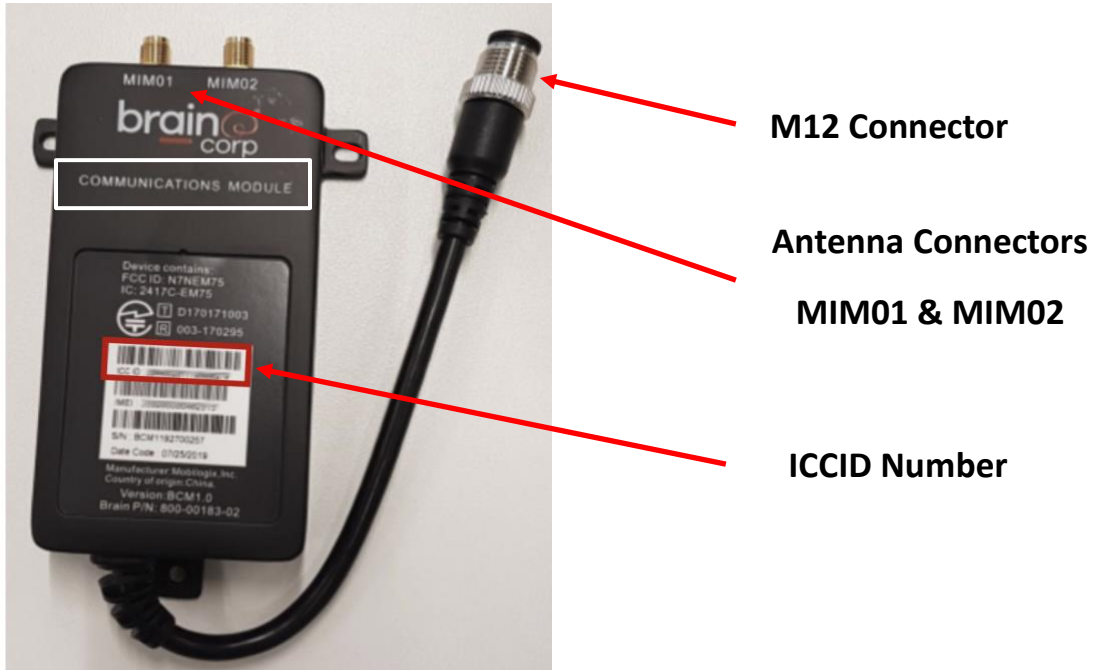
For the Brain Corp communication module, look for the “Communications Module” sign across the top of the device, underneath the Brain Corp logo. There are three connections which interface to the Brain Communication Module: M12 connector, 2 antenna connectors (MIM01 & MIM02).

Figure 6: Brain Communication Module

- 1) Inspect the modem for physical issues.
- 2) Disconnect, inspect and reconnect the cables from the modem to the antenna (MIM01 and MIM02), and the power cable (from the up trunk/upper harness to the modem).
- 3) 📷 Take a picture of the [ICCID](#) number on the modem (example shown above). 📷

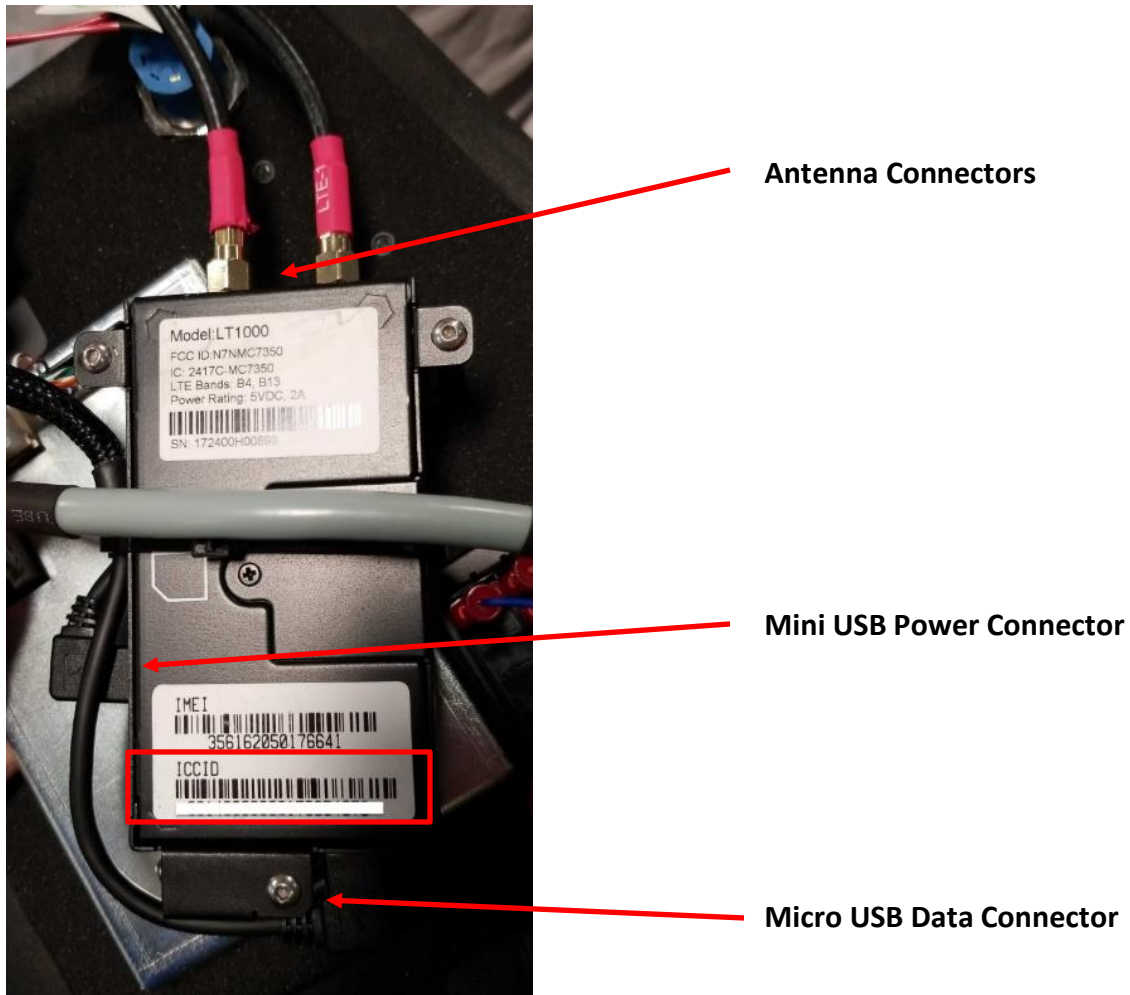
For the LT 1000 Modem, there are four connections which interface with the LT 1000 Modem: mini USB Power connector, micro USB Data connector and 2 antenna connectors: MIM01 and MIM02.

Figure 7: LT 1000 Modem

- 1) Inspect the modem for physical issues.
- 2) Disconnect, inspect and reconnect the cables from the modem to the antenna (MIM01 and MIM02), and the power cable (from the up trunk to the modem).
- 3) 📷 Take a picture of the ICCID on the modem (example shown above). 📷

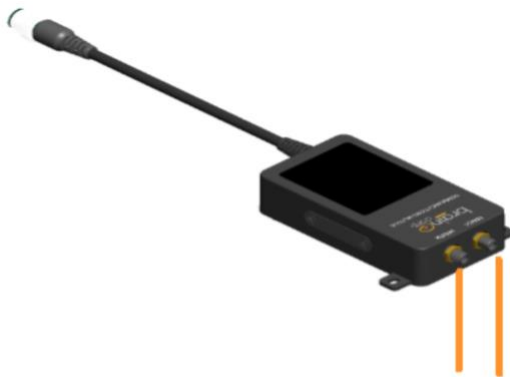
If the modem is visibly damaged (cut, torn or burnt wire, bent pins, etc.) or the MIM01 and MIM02 connectors on the modem spin, the modem needs to be replaced. Refer to solution code [MODEM-01](#).

Figure 8: Modem MIM connectors (indicated by orange lines) should not spin

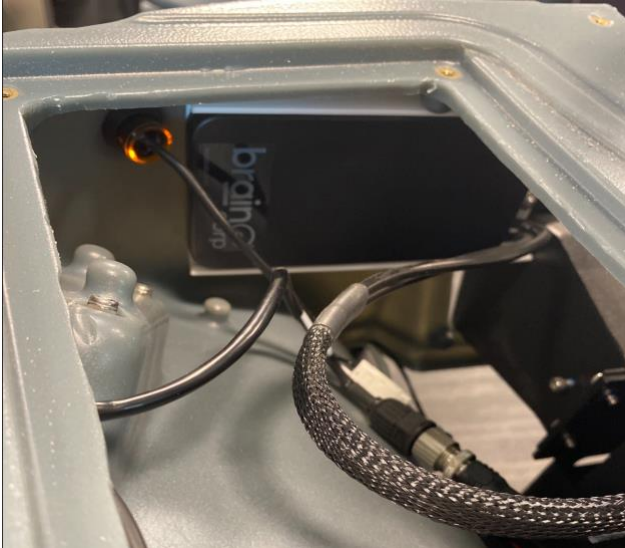
- 1) Locate the antenna underneath the touchscreen display.

Figure 9: Antenna location underneath touchscreen display

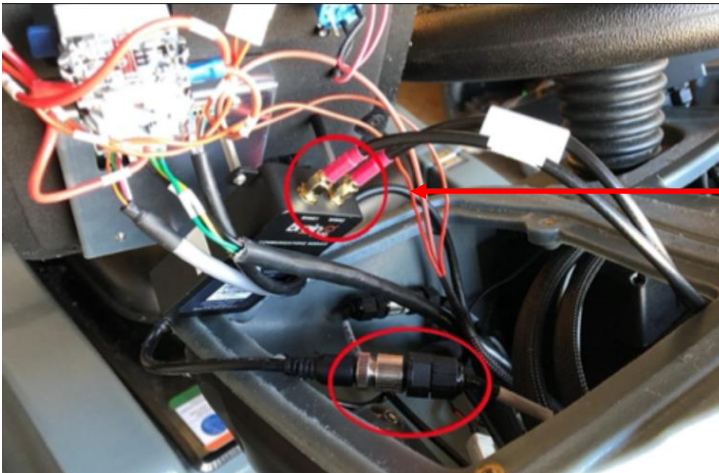
MIM01, MIM02 Cables

- 2) Ensure the antenna MIM01 and MIM02 cables connected to the modem are secure (hand tight).

Figure 10: Ensure antenna cables are secure

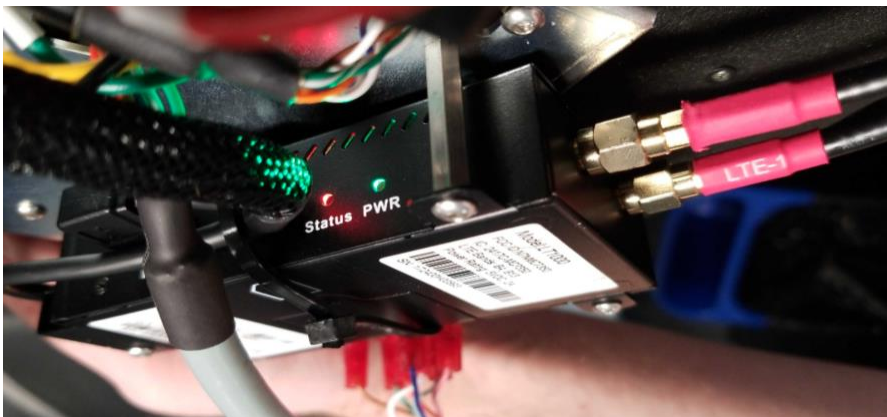
- 1) Ensure the machine is powered on.
- 2) The modem has two LEDs labeled: **Status** and **PWR**. The **PWR** LED should stay on constantly once the machine is powered ON.
- 3) Check that the **PWR** LED is ON solid.

Figure 12: LT 1000 Modem LED Indicators

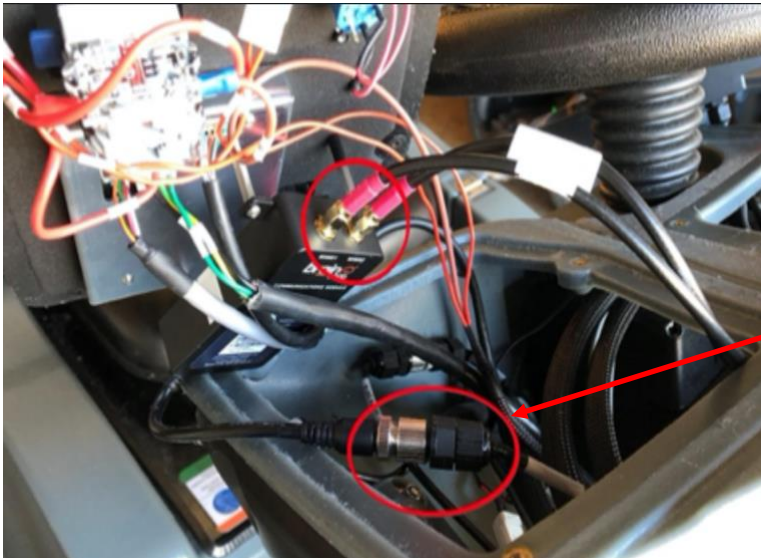
- 1) Unplug the M12 power connector going to the modem.

Figure 13: M12 Power Connector

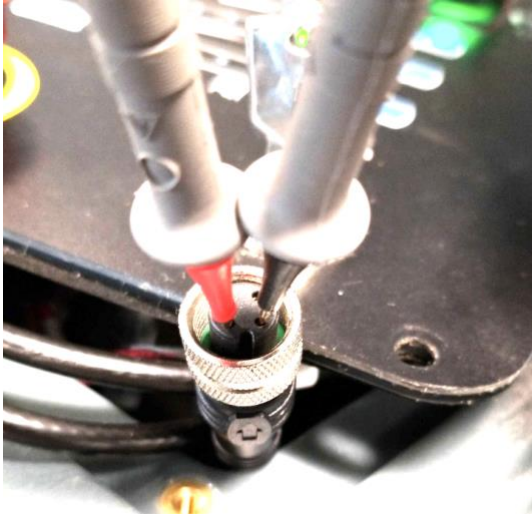
- 2) Using the Digital Multimeter (DMM), measure the voltage at the pins on the M12 female connector as shown below (note the location of the M12 notch).

Figure 14: Red voltmeter probe on pin 2

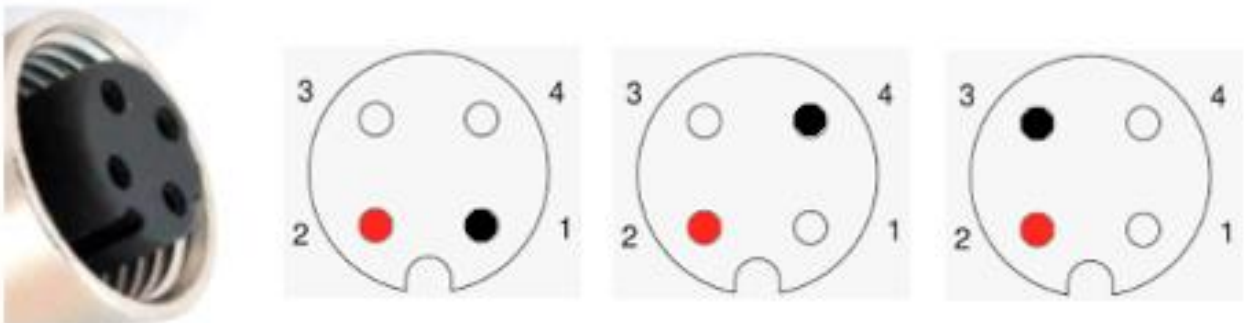
- a) Measure voltage across pins 2 and 1. Expected voltage: About 5VDC. Record exact measured voltage in the [checklist](#).
- b) Measure voltage across pins 2 and 4. Expected voltage: About 5VDC. Record exact measured voltage in the [checklist](#).
- c) Measure voltage across pins 2 and 3. Expected voltage: About 5VDC. Record exact measured voltage in the [checklist](#).

Figure 15: Female M12 Connector and Pin Voltage Measurements

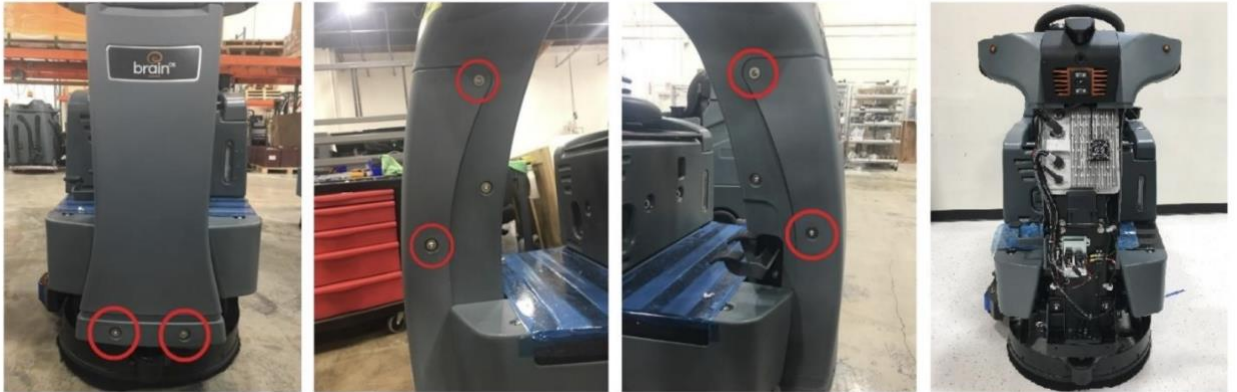
Figure 16: Removing both access panels

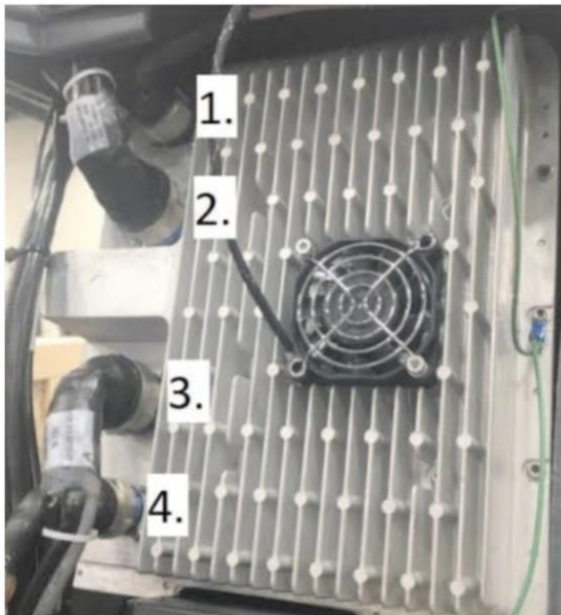
- 3) Remove the up trunk (connection #2) to inspect wiring for physical issues.

Figure 17: BCM Connections

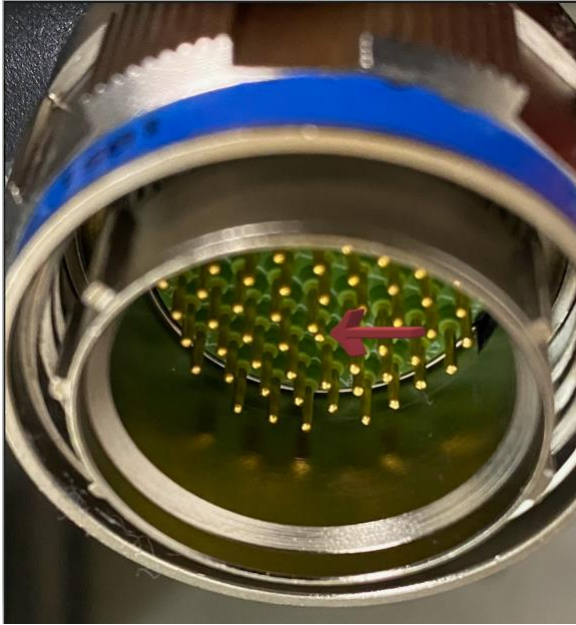
- 4) 📷 Take pictures of the up trunk male connector on the BCM side and the condition of the pins. 📷

Figure 18: Example of Up Trunk with pushed pins

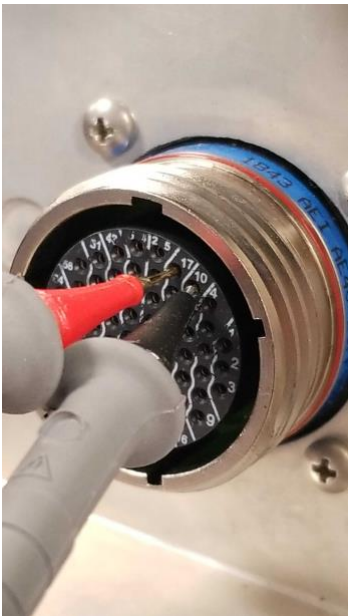
Figure 19: red voltmeter probe on pin 17

- 7) Measure voltage across pins 17 and 18. Expected voltage: About 5VDC. Record exact measured voltage in the [checklist](#).
- 8) Measure voltage across pins 17 and 10. Expected voltage: About 5VDC. Record exact measured voltage in the [checklist](#).

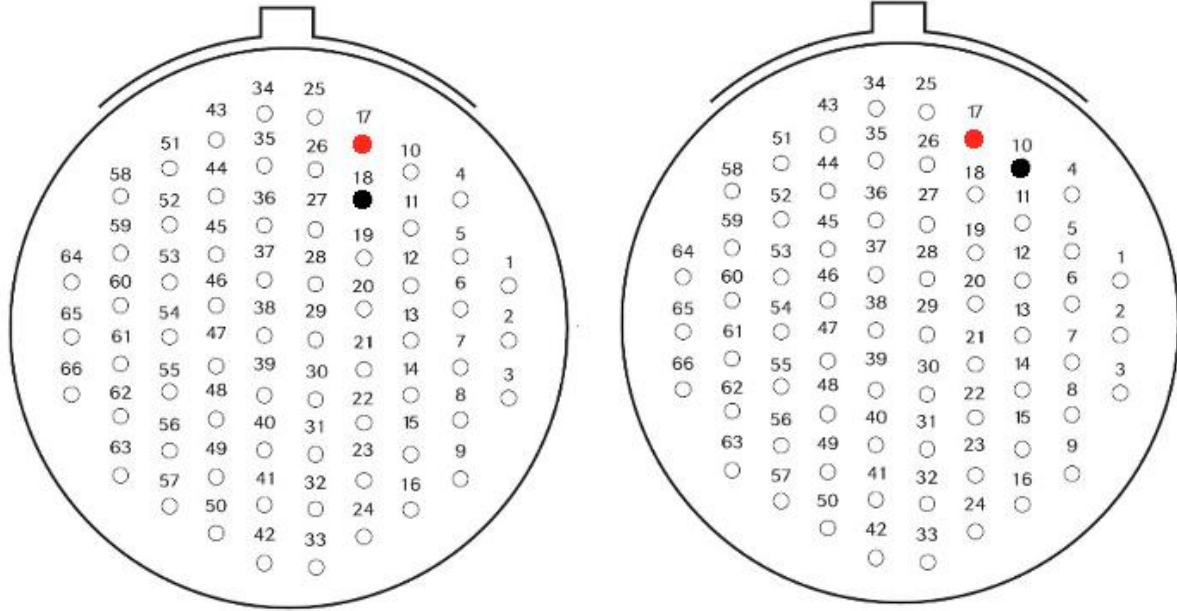
Figure 20: Example of BCM PIN with power
