February 8, 2010

Model: Stealth ASD26BT

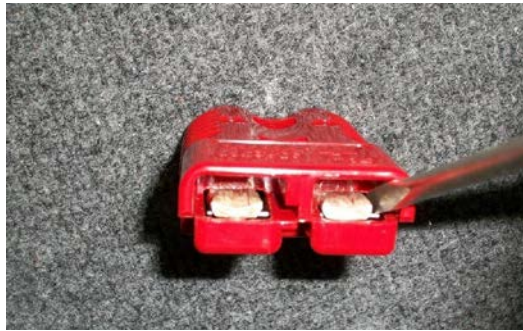
An issue with the battery connectors has been noticed in some of the Stealth ASD26BT machines. In some instances it may be difficult to connect the Anderson plugs. If you are experiencing this issue, follow the steps below for a permanent correction.

1. Remove the lugs from the plug by depressing the spring plate and pulling the cable through the back of the plug.
