TVA valve Y42 and boost pressure sensor B4 cleaning procedure

M29- CM 2200

(R750EU6 engines)

SA 26.03.2019 / rev.02

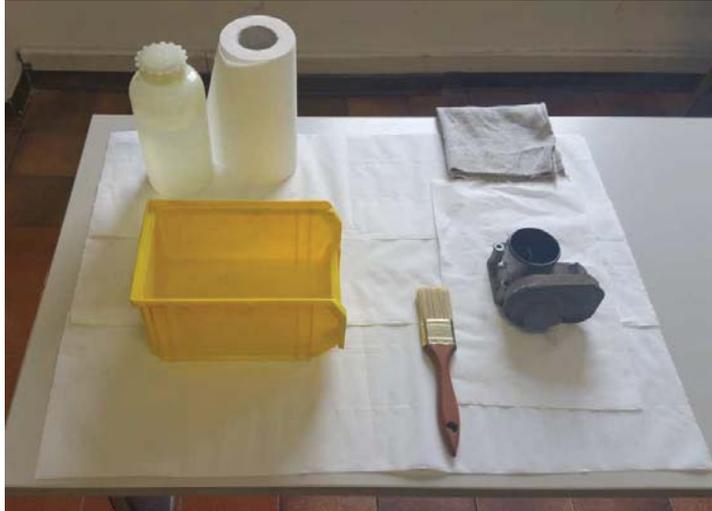
Material preparation

Prepare for good cleaning:

- One Container
- Degreaser like brake cleaner
- A soft brush
- O-Ring (article number 46320277F)
- O-Ring (article number 46320266F)
- Hex- wrench 3 mm
- Wrench 8 mm

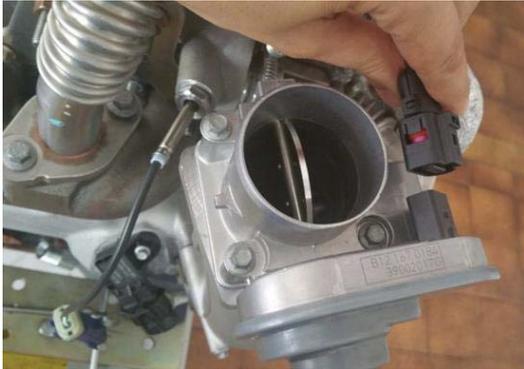
A
Disconnect
the plug

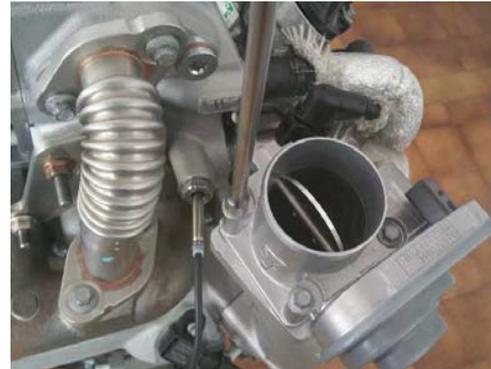
B
Loosen the 4
screws with an 8
mm wrench

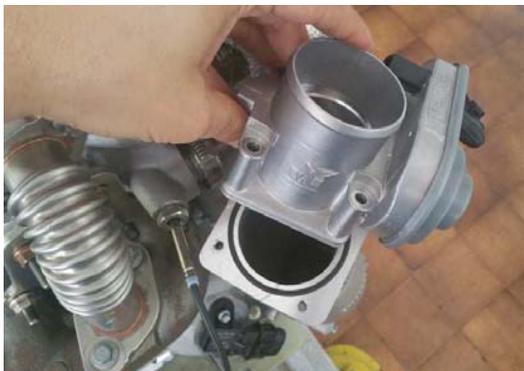
C
Remove
the TVA

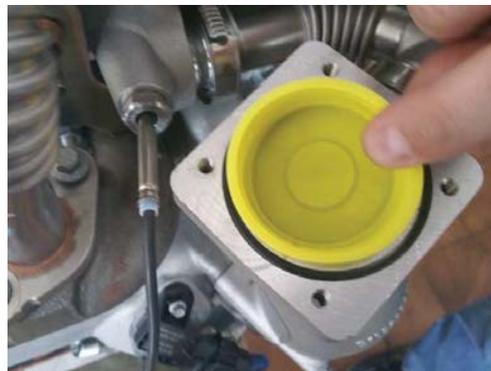
D
Seal the intake
elbow with an
appropriate
cap to prevent
foreign material
ingestion

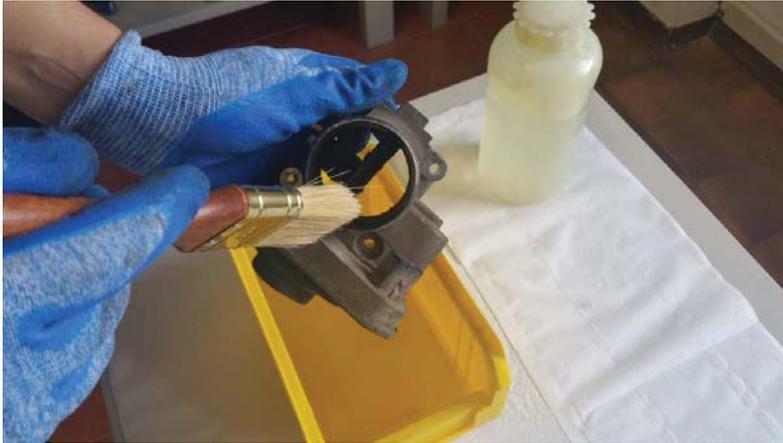
Clean the valve with degreaser

Attentions!
To avoid damage to electrical parts, do not completely immerse the valve in the solvent.

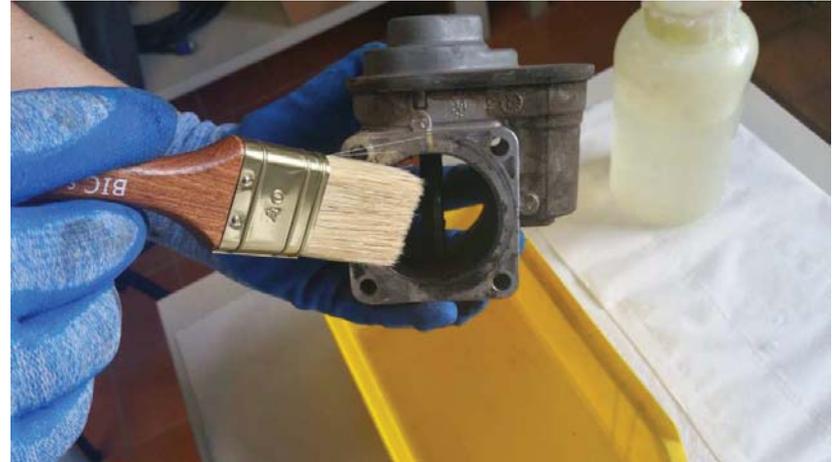
Clean valve with degreaser

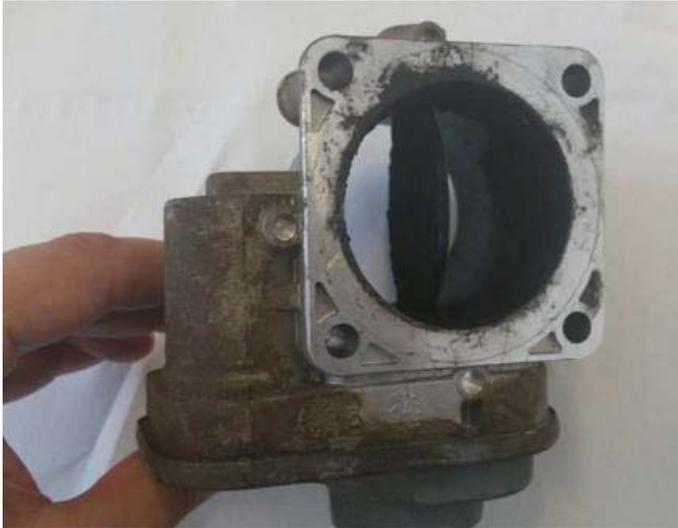
Before cleaning

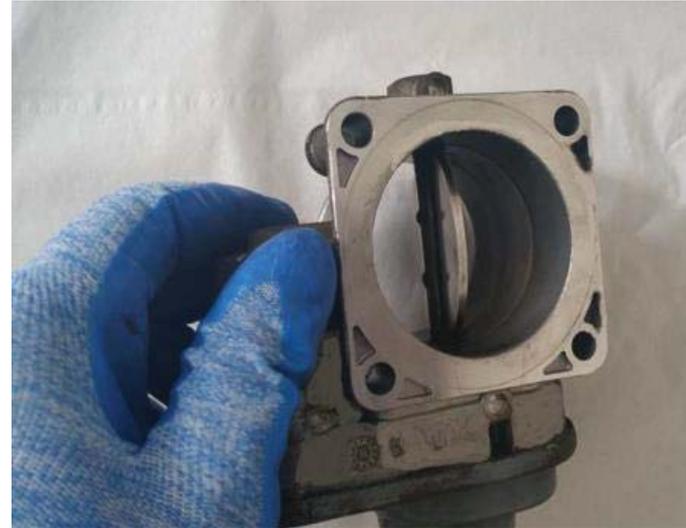
After cleaning

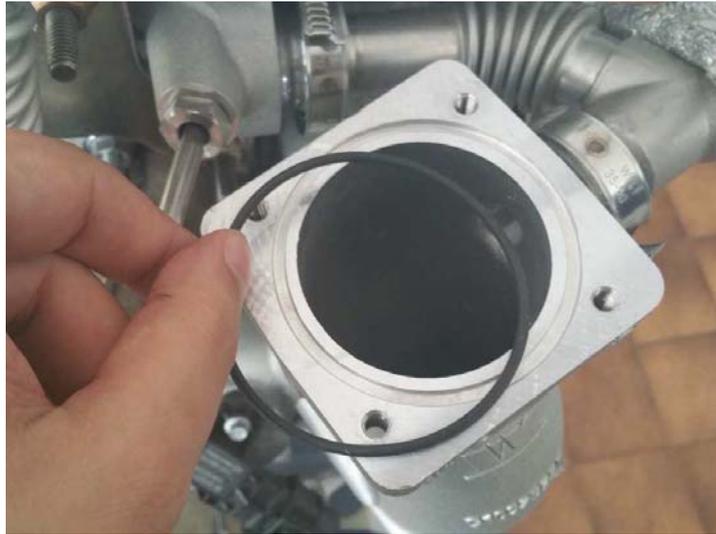
Valve reinstall

- Make sure to remove the elbow sealing (cap)
- Make sure to install the new O-ring.
- Reinstall the valve in reverse order starting with point C on page 3

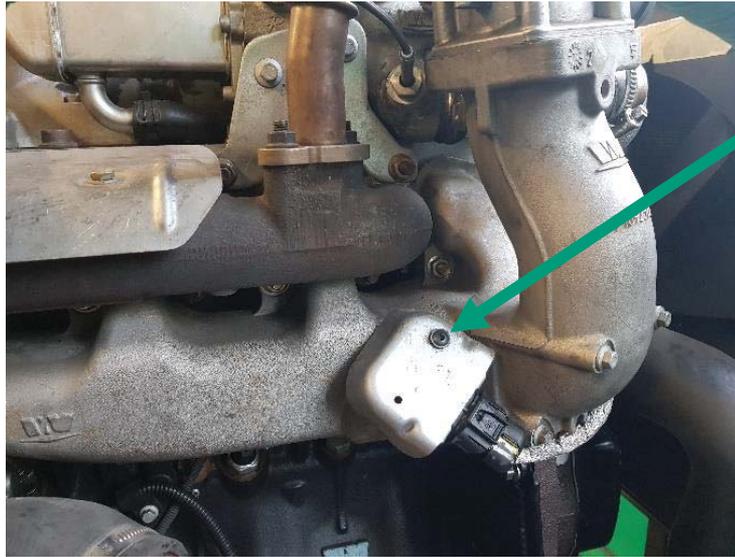
Loosen the screw
with a 3 mm hex-
wrenge

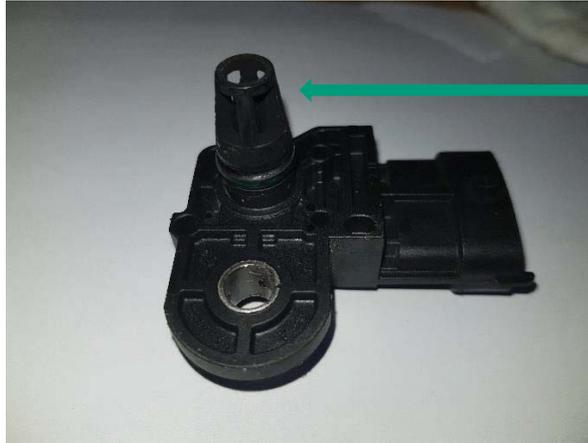
Cleaning and blowing out

- Clean the sensor with the brake cleaner.
- Then blow out everything with air.
- Replace the O-ring (article number 46320266F)
- Reinstall the sensor

If the error P0299-01 was the reason for the cleaning, a regeneration of the particle filter must be carried out after deleting the error!
